REPORT OF MARINE SURVEY

"Aquarius"

Mark Corke
Yacht and Marine Surveyor

PREPARED EXCLUSIVELY FOR:
Mr M Gable and Mr A Thompson
June 29th 2012

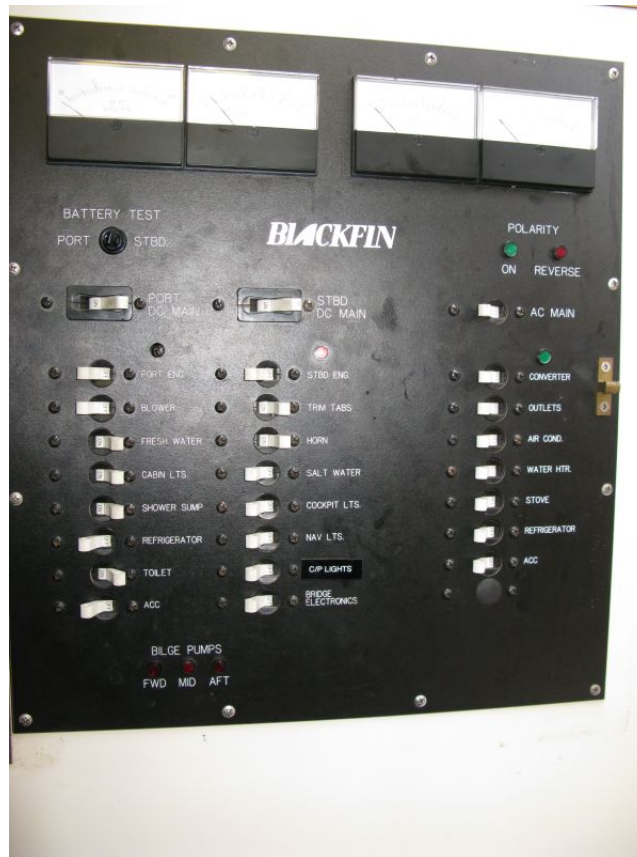
DC/ AC panel

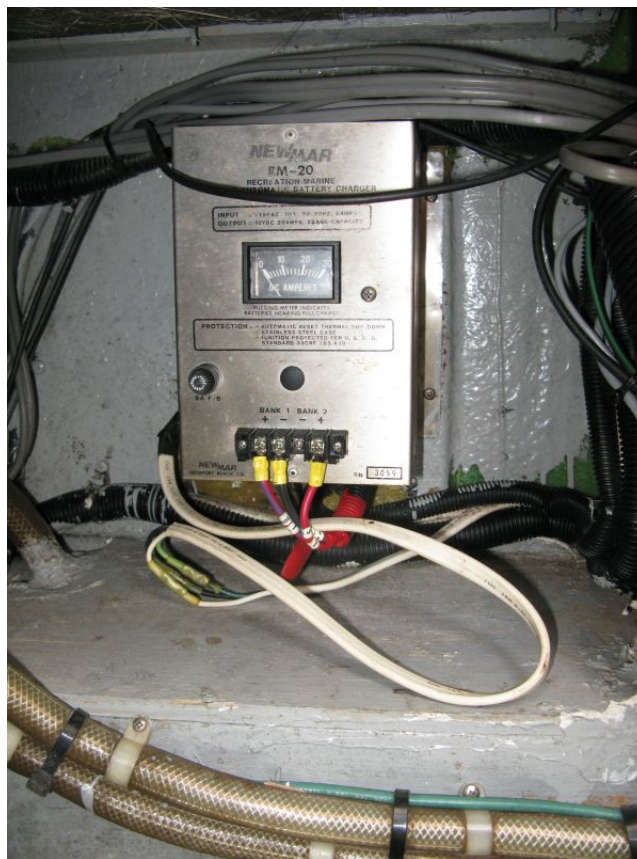
20 amp battery charger
