REPORT OF MARINE SURVEY

"Aquarius"

Mark Corke
Yacht and Marine Surveyor

PREPARED EXCLUSIVELY FOR:
Mr M Gable and Mr A Thompson
June 29th 2012

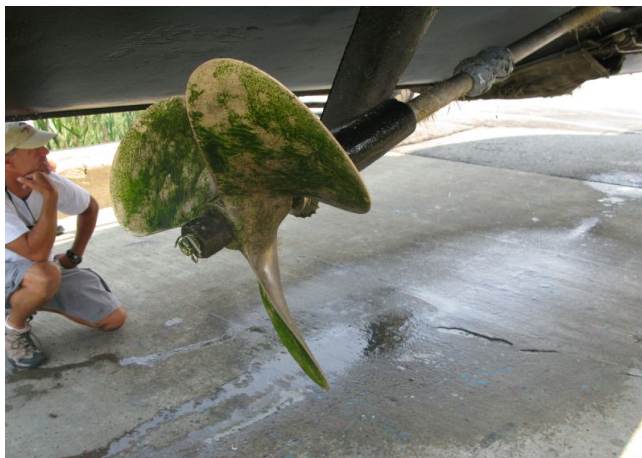
The boat is powered by a pair of Volvo Penta freshwater cooled diesel engines driving through reduction gearboxes of 1.9 to 1 ratio, traditional shaft seals/stuffing boxes and stainless steel propeller shafts of one and a half inch diameter and three bladed bronze props of 19 inch diameter and 19 inch pitch. Cutlass bearings were checked with the boat out of the water and all appeared satisfactory.

The engines have been rebuilt at different times in the recent years and I am uncertain as to the exact amount of running hours since that time

It was noted that the water pump on the starboard engine appears new. The numbers on the engines have been obliterated and I was unable to record the numbers but these should be listed on the service records for the engines.

Both engines are mounted on soft engine mounts which appear in good condition at this time. Access to the engines is garnered by raising the hatch covers in the cockpit sole which allows for routine checks and servicing. There were no oil leaks or other visible maladies present at the time of inspection save for those mentioned in the notes and corrections section of this report

Fuel is fed to the engines from a single aluminum fuel tanks, through fuel filter/water separators thence to the engine intakes. The fuel system appears well maintained and in compliance with ABYC guidelines. Bennett trim tabs are operating, all of which appear satisfactory at this time.
